# OCCUPIED PALESTINIAN TERRITORY

## GAZA STRIP

IMAGERY ANALYSIS: 29 February 2024 / PUBLISHED: 20 March 2024 / V1

### UNOSAT Damage Assessment Overview Map

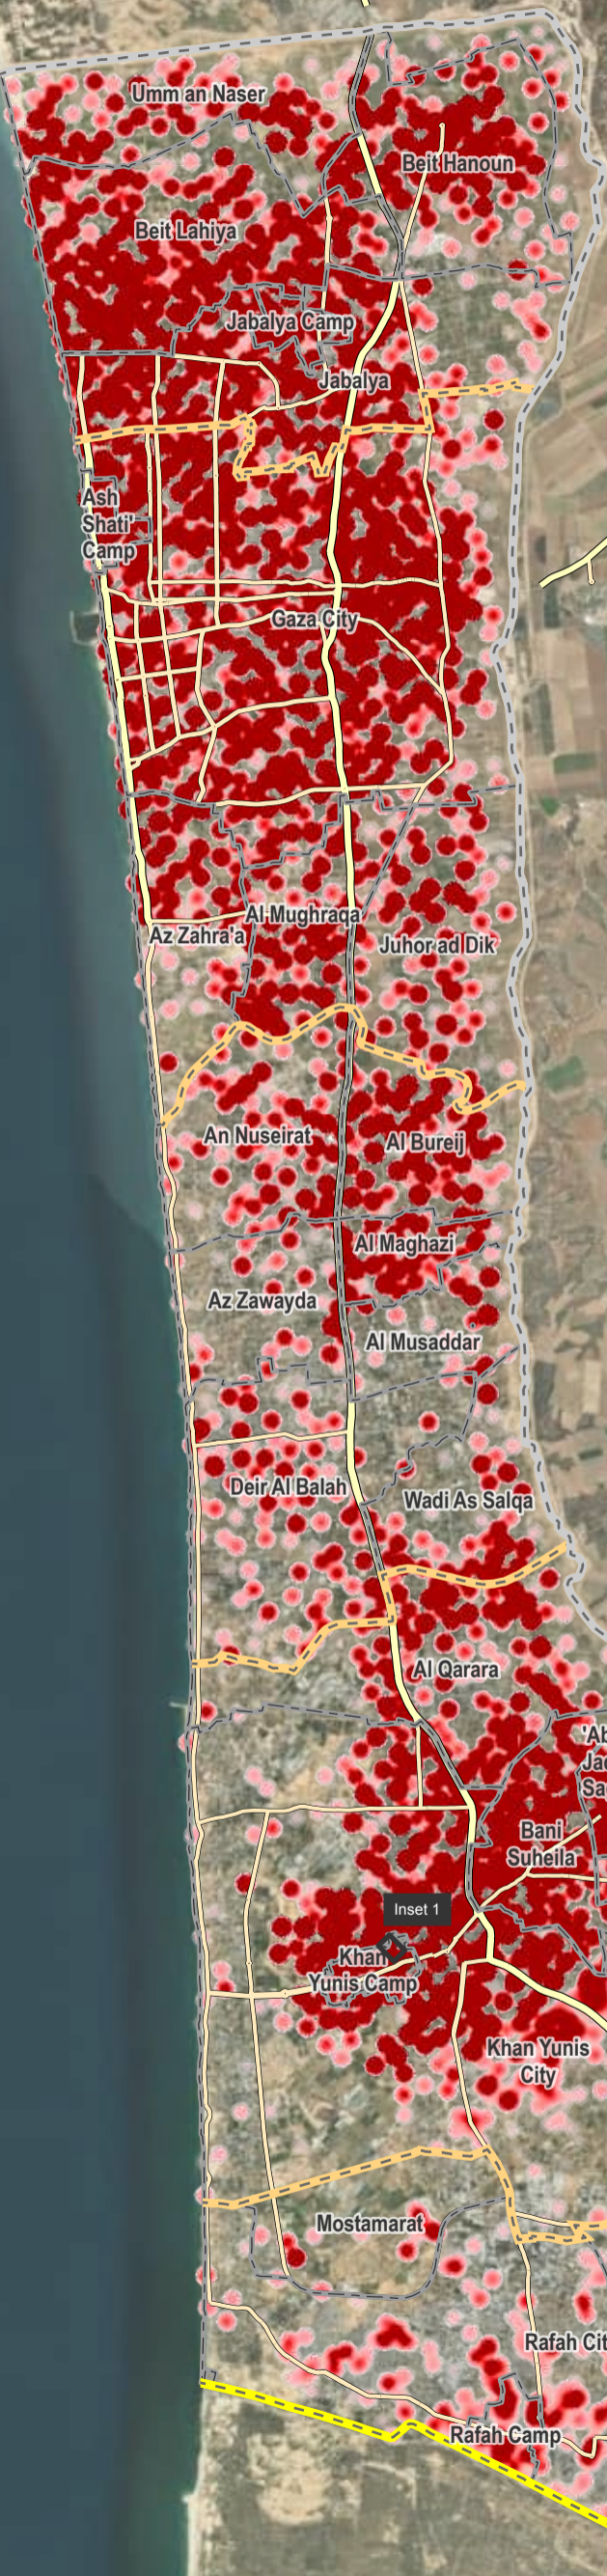
This map illustrates a satellite-imagery based comprehensive assessment of damage and destruction to structures within the area of interest in the Gaza Strip, Occupied Palestinian Territory, based on images collected on 29 February 2024 when compared to images collected on 1 May 2023, 10 May 2023, 18 September 2023, 15 October 2023, 7 November 2023, 26 November 2023, and 6-7 January 2024. According to satellite imagery analysis, UNOSAT identified 31,198 destroyed structures, 16,908 severely damaged structures and 40,762 moderately damaged structures, for a total of 88,868 structures. These correspond to around 35% of the total structures in the Gaza Strip and a total of 121,400 estimated damaged housing units. The governorates of Khan Yunis and Gaza have experienced the highest rise in damage, with 12,279 new structures damaged in Khan Yunis and 2,010 in Gaza. Khan Yunis City had the highest number of newly destroyed structures, with 6,663 in total. This is a preliminary analysis and has not yet been validated in the field.
